Washington State  
School Seismic Safety Assessments Project

# CAMELOT ELEMENTARY SCHOOL MAIN BUILDING Federal Way Public Schools

SEISMIC UPGRADES CONCEPT DESIGN REPORT

June 2021

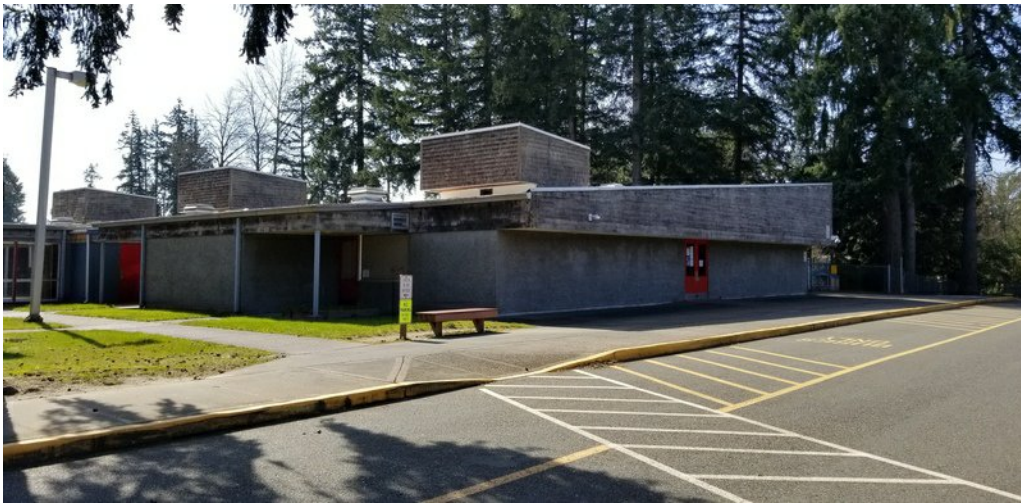
**Figure 1-1. Exterior Building C**

Camelot ES is composed of three, one-story wood shear wall structure with stucco/gravel facades on the exterior walls. The buildings were originally constructed in 1964 and had a renovation in 1988. The buildings are all roughly rectangular in plan. Building R is the Multi-Purpose Room and measures 90 by 81 feet. Buildings A & B classroom buildings that nearly identical in footprint and measure 187 by 72 feet. The buildings have mono slope roofs with Multipurpose Building R having average height of 22.5 feet, and Classroom Buildings A & B having an average height of 12.5 feet. The building roofs are interconnected with a series of breezeway roof segments.
